Elevator Incident Investigation Crockett Hotel, San Antonio

Location: Crockett Hotel 320 Bonham Street, San Antonio, TX 78205

ELBI: 3325 **Decal:** 010070

Date of Incident: December 28, 2011

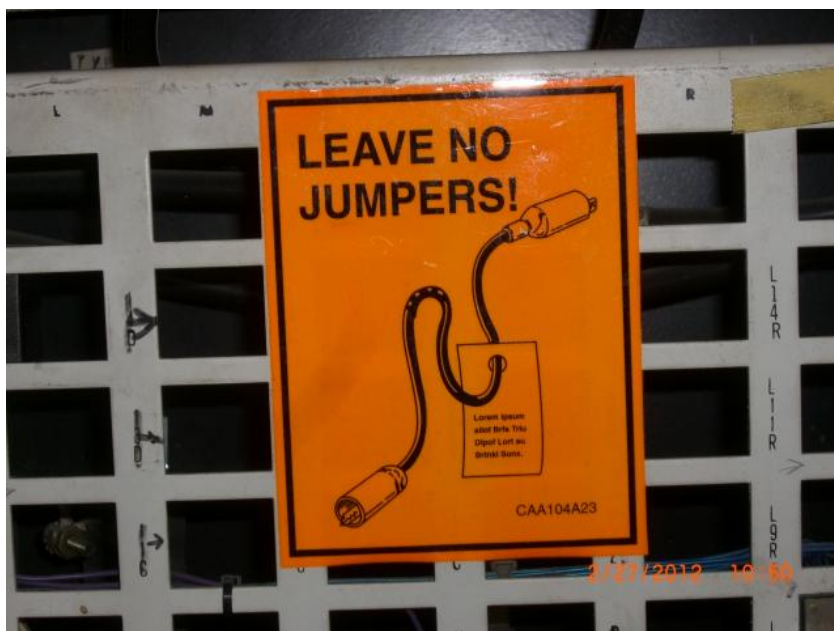
A preponderance of the evidence indicates that someone (who exactly, is unknown) knew that something was wrong with the drive machine brake as evidenced by the jumper seen upon the brake resistor. The placement of that jumper took an intentional and deliberate act and would only have been undertaken in response to some noted abnormality by someone with unique knowledge of the elevator equipment controls. How long the jumper was in place prior to the incident and the investigation cannot be determined. The installation of the jumper is a violation of both the elevator code and the posted instructions pasted onto the elevator controller swing panel by the maintenance contractor. See below:

In this case, the use of jumpers indicates a failed attempt to treat the symptoms of brake trouble when the disease was the fact that the brake itself was not installed, adjusted and maintained as prescribed by the manufacturer. It was found that the manufacturer's brake replacement and adjustment instructions were not readily available for their employees to use. Even when installing new replacement brakes, they had no instructions and were deliberating amongst themselves how to go about properly adjusting the brake. The undeniable fact is that the old brake was capable of being adjusted properly and appeared to function correctly after being properly adjusted.

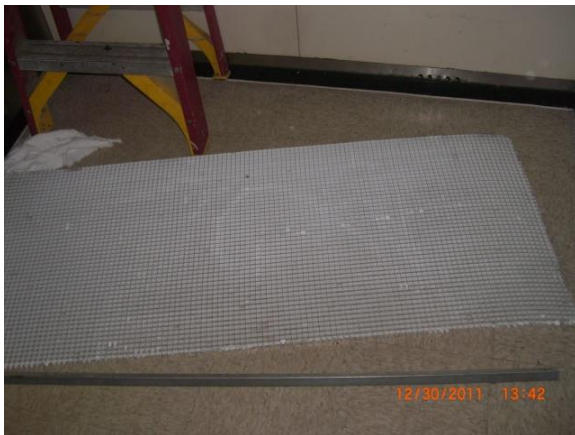
Crockett Hotel-010070

Ceiling and piece of frame found on car floor
assumed to have fallen due to counterweight
impact

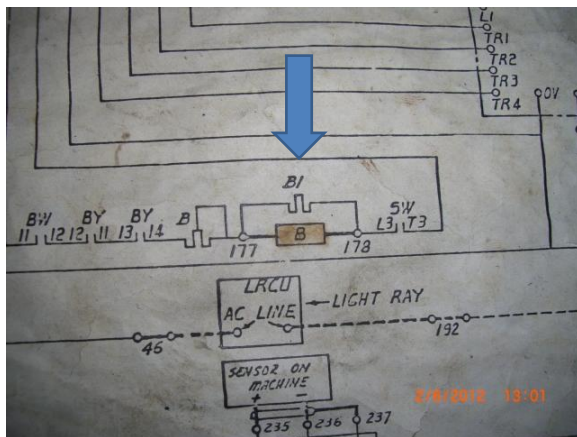
At this point the voltage across the brake coil was measured and found to be 108 VDC. After removing the jumper that bypassed the series brake resistor "B" the voltage was found to be 104 VDC. As previously noted the brake parallel resistor "B1" was bypassed by having had its top wire relocated to the bottom terminal effectively removing it from the circuit. A photo of that circuit is below. The red jumper was on series resistor "B" and the wire on the 177 side of parallel resistor "B1" was moved to electrically be located on the 178 terminal side of that resistor. The effects of these actions were to:

Crockett Hotel-010070

Resistors B is jumped out on the controller with wire jumper and B1 has been bypassed by moving wire 177 to 178

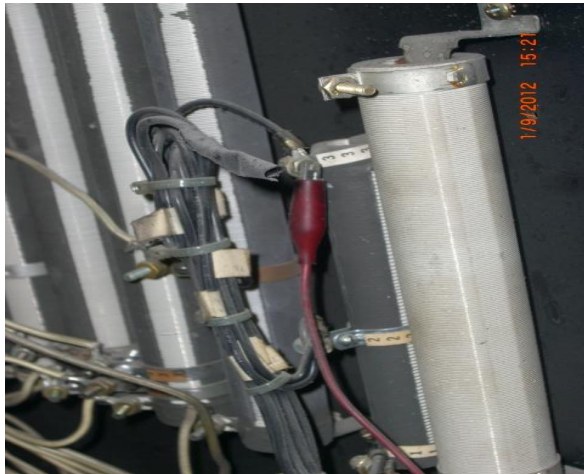
Crockett Hotel-010070

Jumper left on resistor in controller and resistor
bypassed

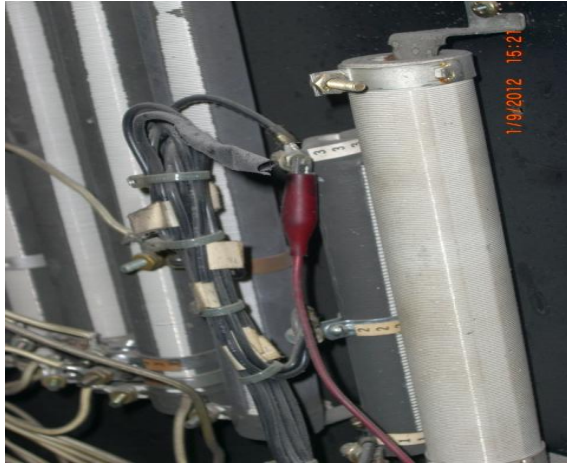
Crockett Hotel-010070

Jumper left on resistor in controller and resistor
bypassed

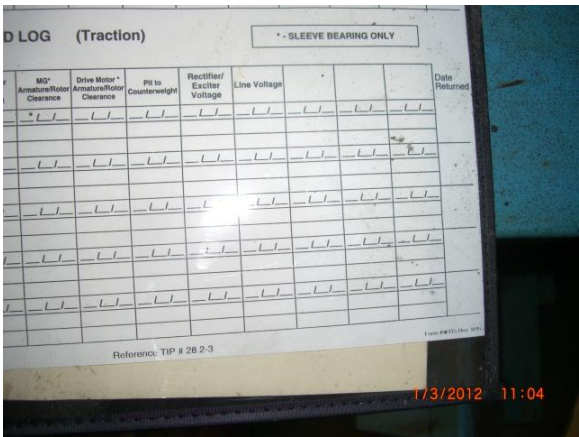
Crockett Hotel-010070
Completely blank maintenance records

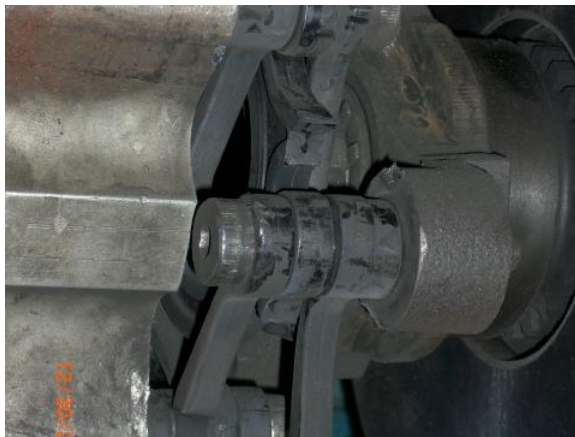
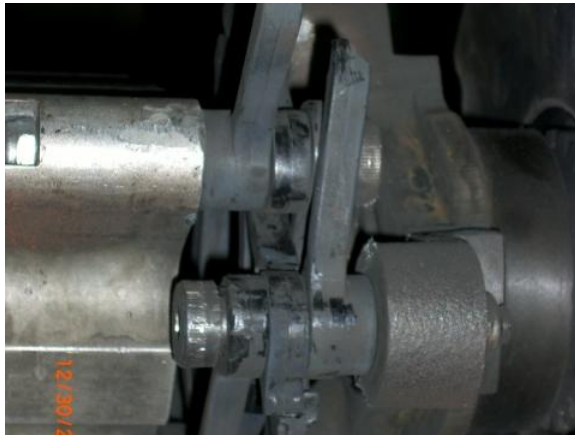
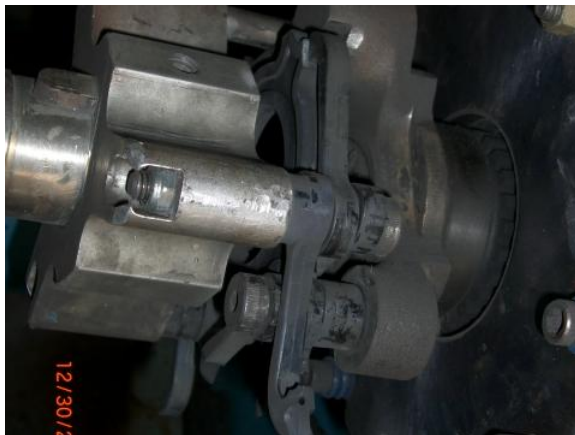
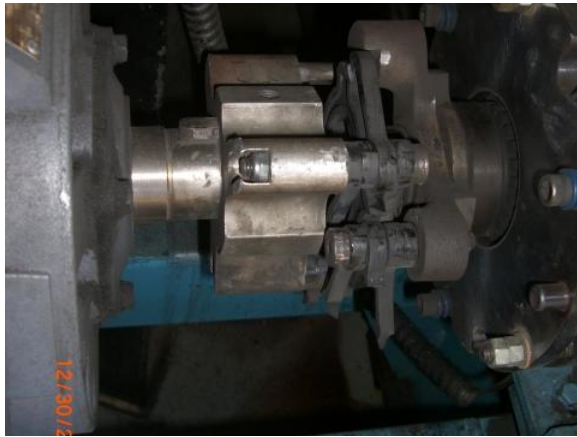
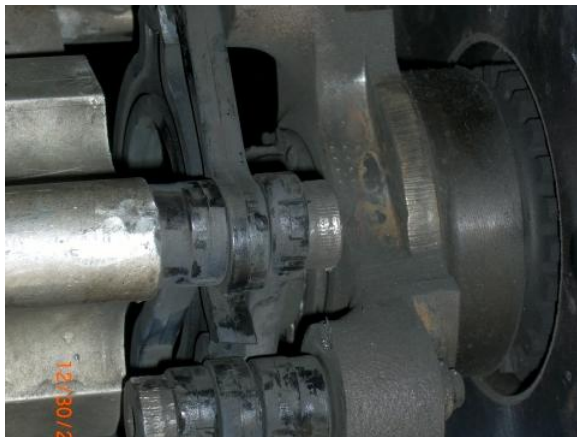
2. The plastic flexible disks in the brake coupling were broken
3. There was oil on the machine room floor underneath the drive machine (A17.1-2007-8.6.4.8.1)

Crockett Hotel-010070
Broken coupling disks

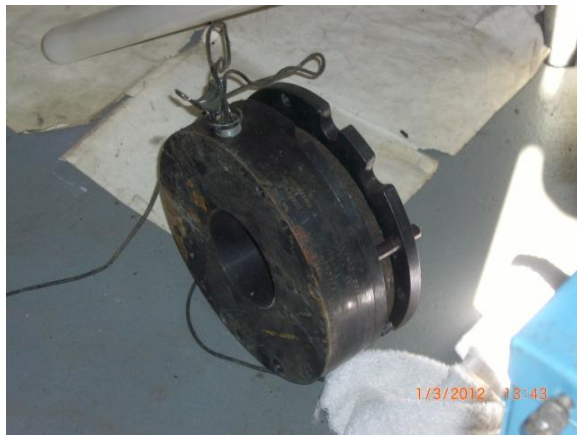
7. There is what appears to be a used drive machine brake indicating that the brake assembly had been previously replaced. There is no evidence that the holding ability of the new brake was verified as required (125% brake test) (A17.1-2007-8.6.4.6.2)

There was a used brake found lying on the floor of the machine room. If and when the brake was replaced is unknown - we have yet to see any records to indicate the brake was replaced. The lack of maintenance records and access to a maintenance control program is troubling. It appears that whoever replaced the brake did it incorrectly and they also failed to adjust the brake in accordance with the manufacturer's procedures.

Crockett Hotel-010070
Previously replaced drive machine brake laying on
the machine room floor

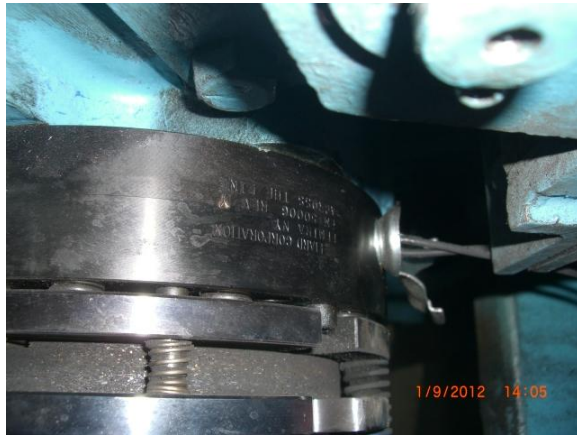
Crockett Hotel-010070

Old drive machine brake and exposed conductors

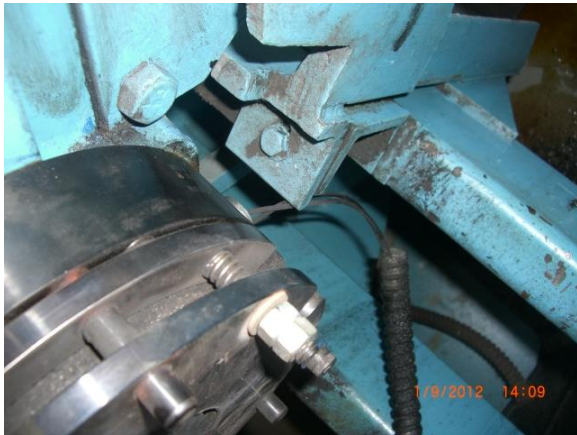
11. Fuse #4 was labeled for a 3 amp fuse but contained a 3.25 amp fusetron time delay fuse
12. The flexible metal conduit at the drive machine brake was pulled loose from the fitting exposing the conductors

Crockett Hotel-010070

Conduit pulled loose from old brake exposing
conductors

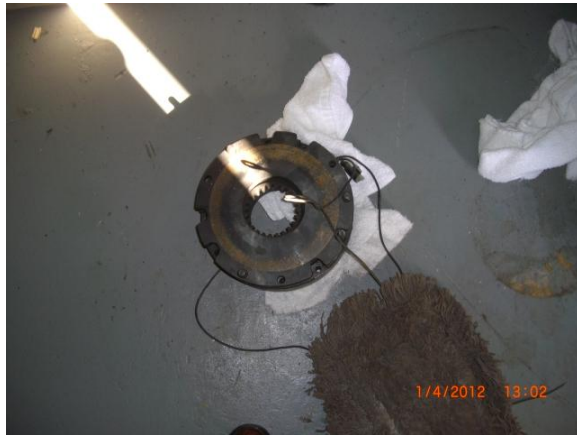
Crockett Hotel-010070

Used drive machine brake found on the machine room floor

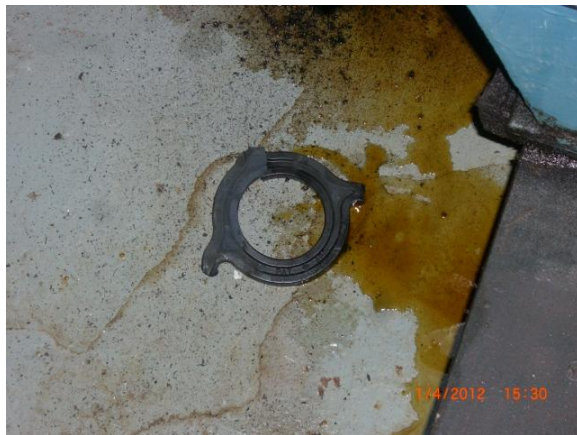
Crockett Hotel-010070

Piece of old coupling disk on the floor of machine room

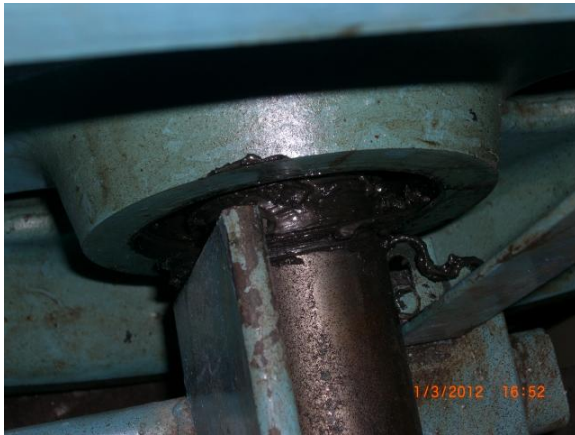
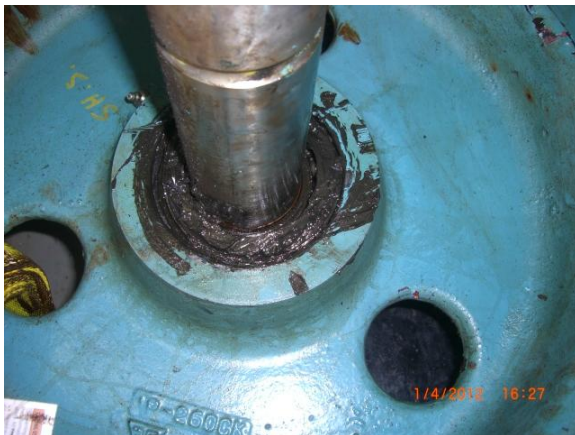
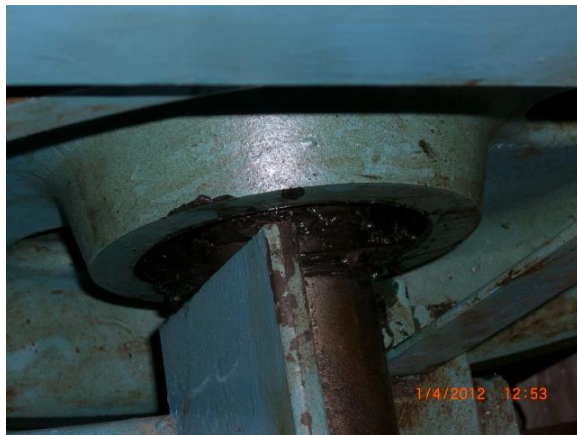
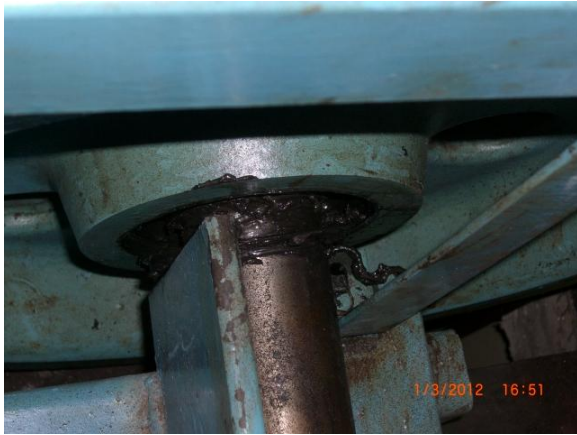
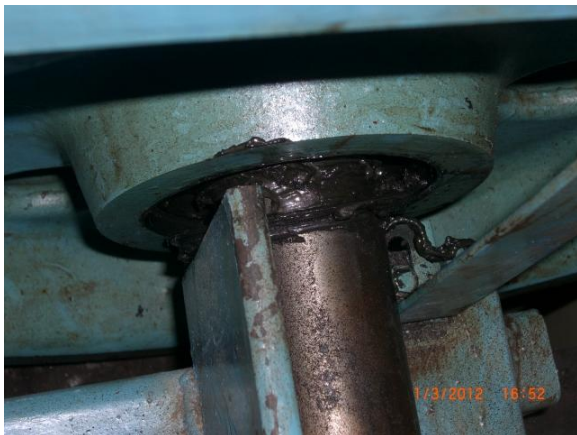
Crockett Hotel-010070
Defective deflector sheave bearings

Crockett Hotel-010070
Defective deflector sheave bearing

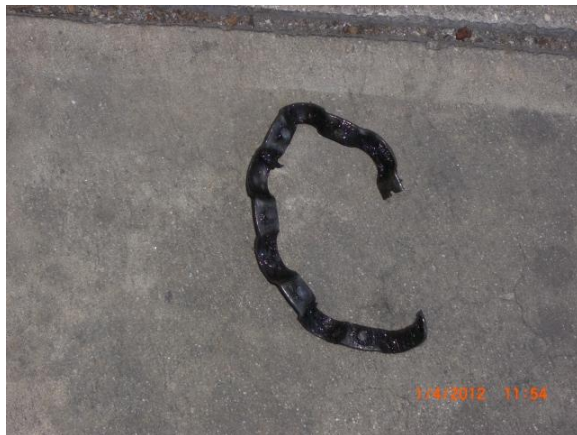
Crockett Hotel-010070

Outer race of deflector sheave bearing broken

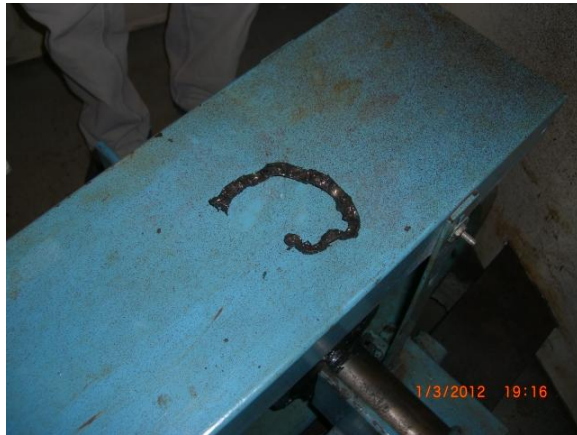
Crockett Hotel-010070

Broken section of deflector sheave bearing

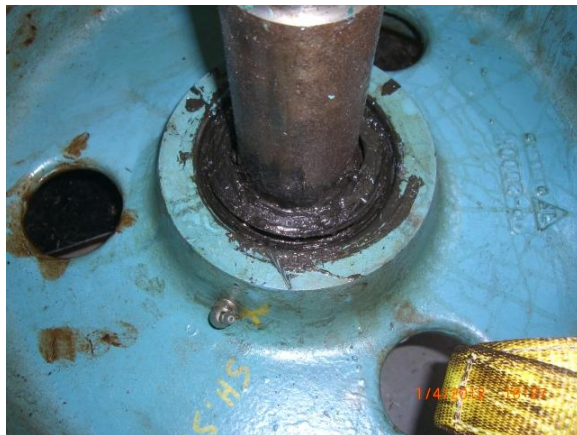
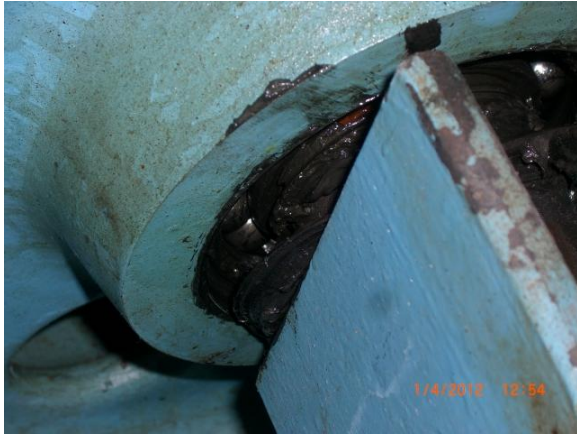
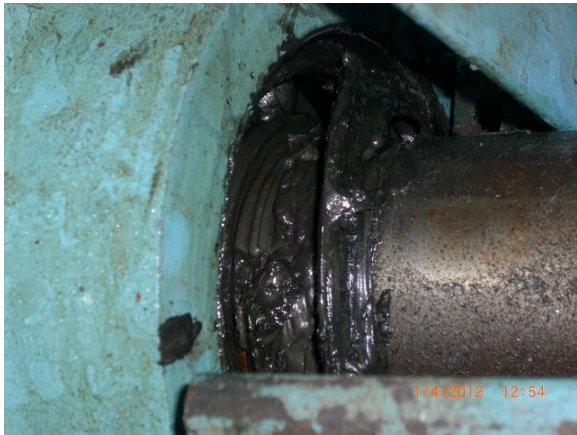
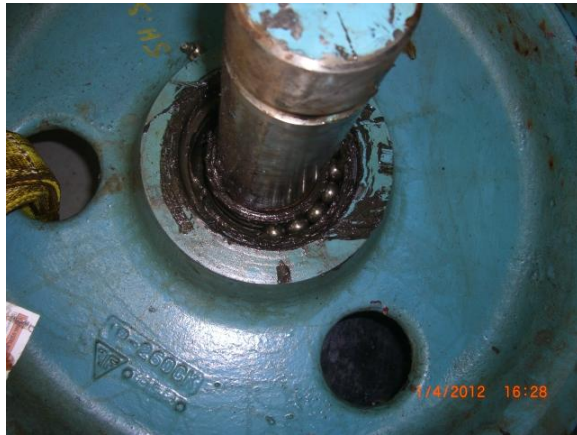
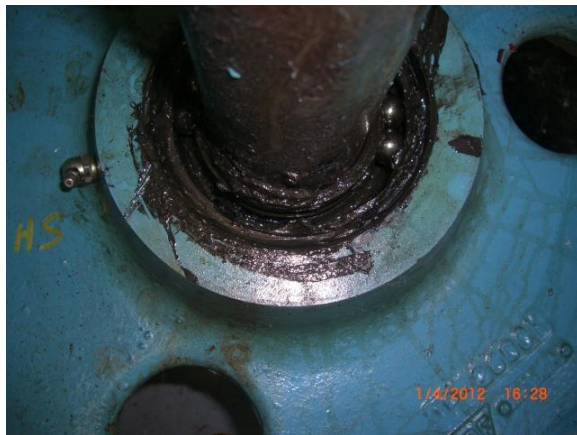
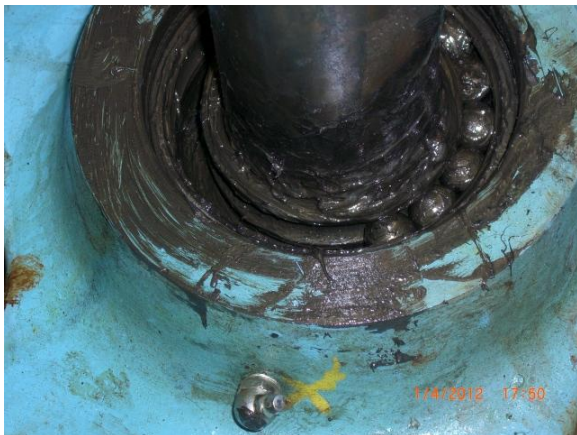
Crockett Hotel-010070

Defective deflector sheave bearing

Crockett Hotel-010070
Defective deflector sheave bearing

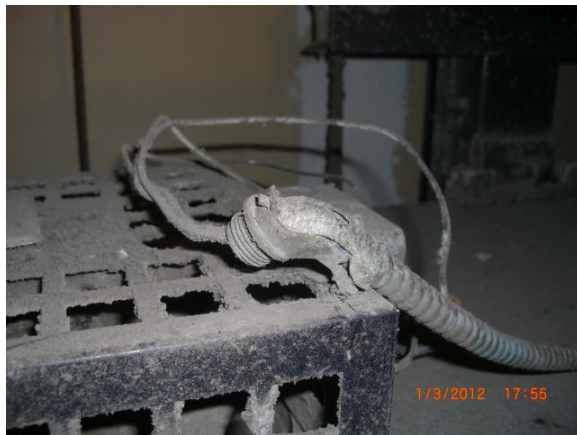
Crockett Hotel-010070

Loose flexible metal conduit fitting with exposed
conductors

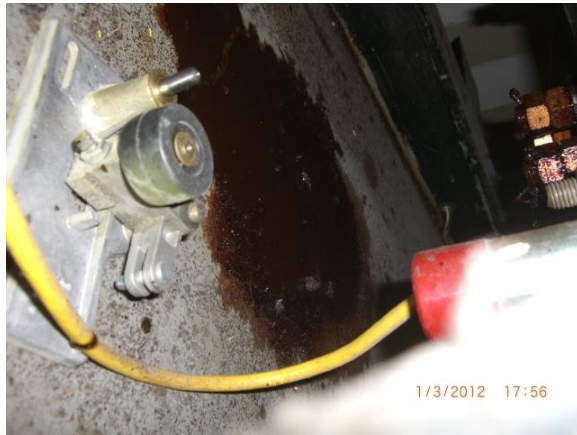
1. The car top was dirty and had oil thereupon as well as used parts. (ASME A17.1-2007-8.6.4.9)
2. There are several flexible metal conduits that are broken and the conductors exposed.

Crockett Hotel-010070

Oil and used parts on the car top

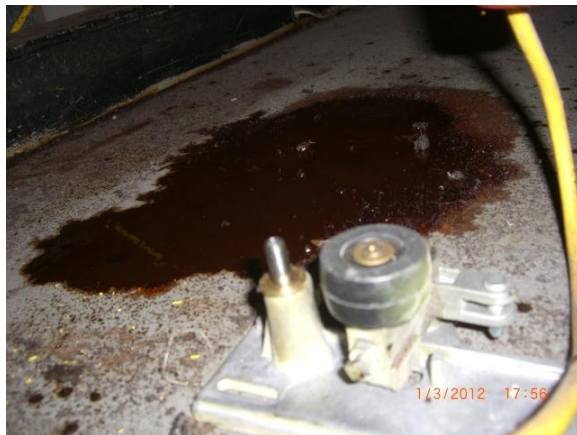
Crockett Hotel-010070

Oil and used parts left on the car top. Also the outer covering of the yellow wire is damaged outside the photo area

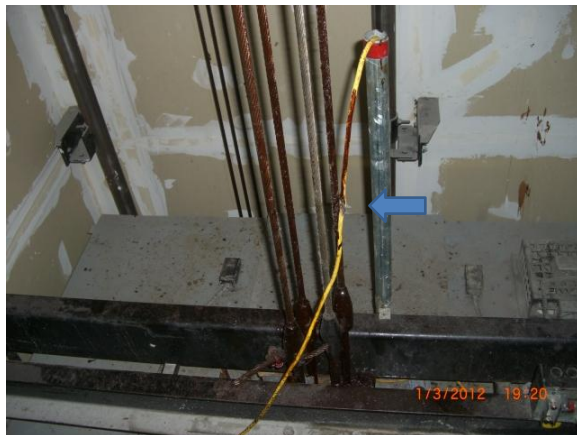
Crockett Hotel-010070

Frayed light cord found on car top

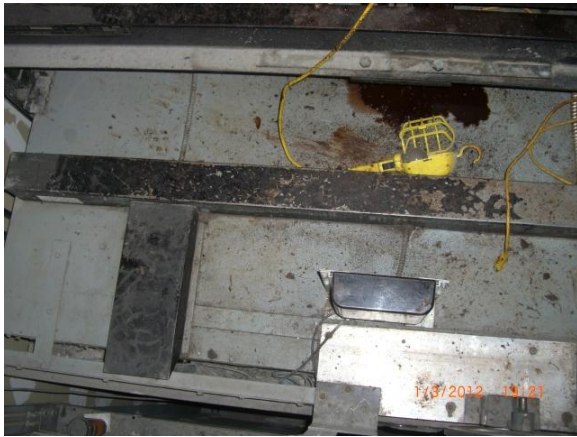
Crockett Hotel-010070

Oil and cord on car top

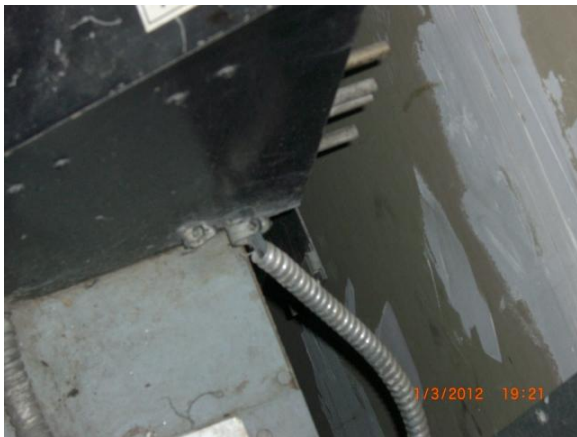
Crockett Hotel-010070

Broken flexible metal conduit on car top

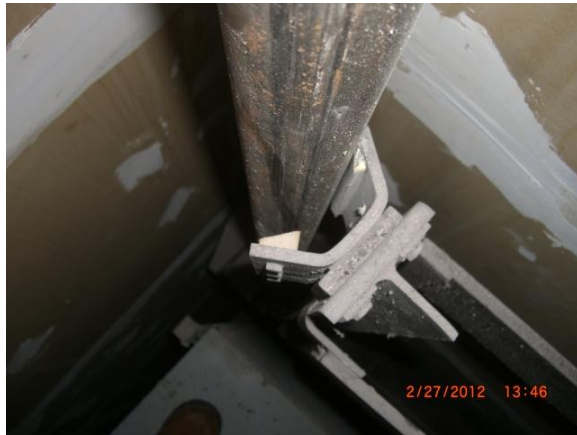
Crockett Hotel-010070

Counterweight guide nearly off the rail

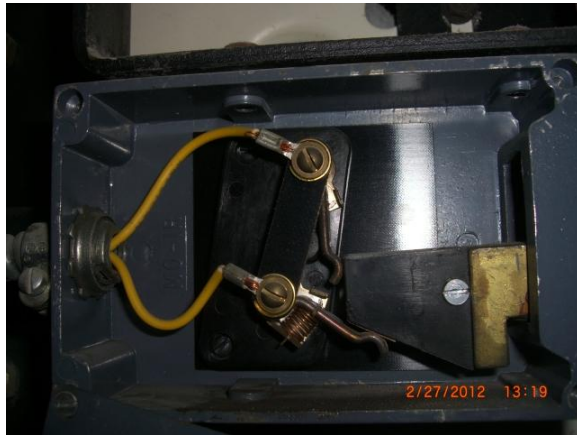
Crockett Hotel-010070
7th floor door lock missing its cover

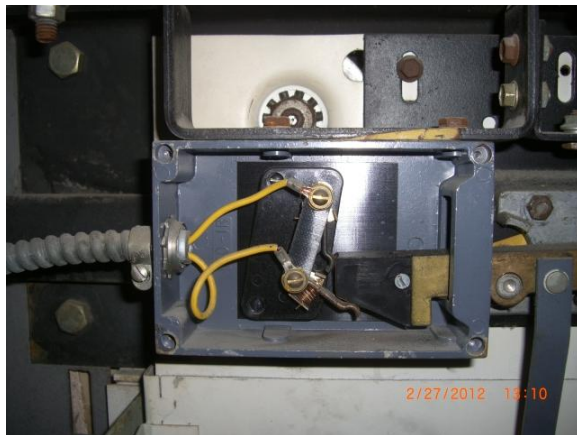
Crockett Hotel-010070
Wiring is not Type SF but as far as I can tell type SF
was not required at the time of installation

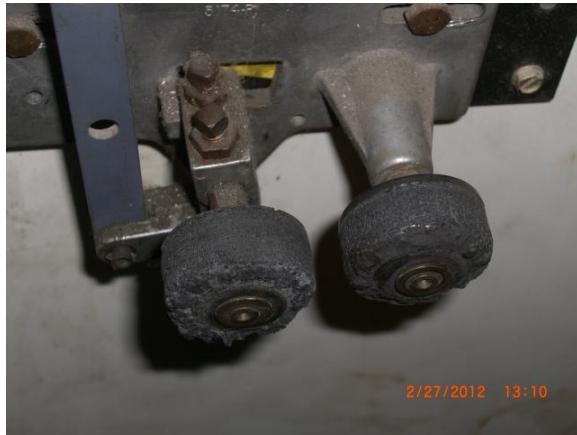
Crockett Hotel-010070

Example of worn door clutch rollers

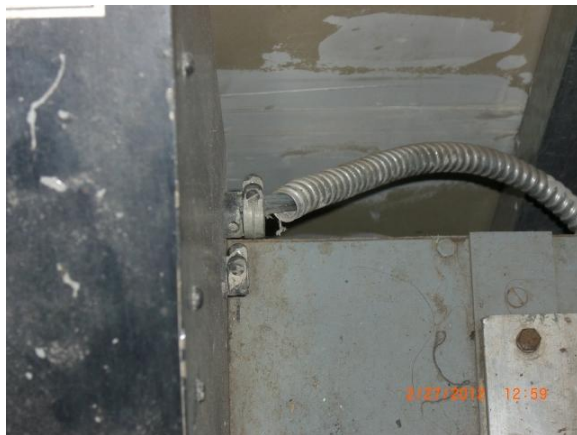
Crockett Hotel-010070

Conduit pulled loose and conductors exposed on
the car top

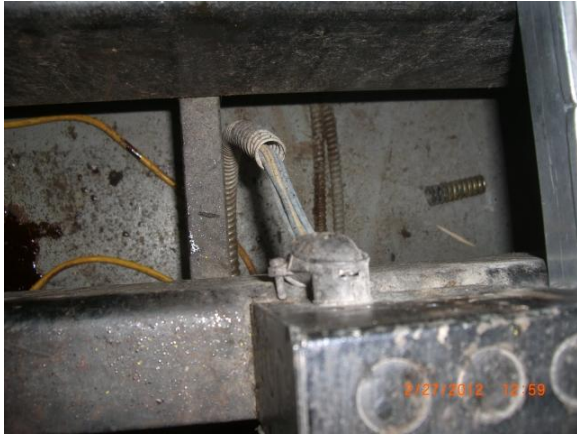
Crockett Hotel-010070

Conduit pulled loose and conductors exposed on
car top
